CORNISH ARCHAEOLOGY

No 32 1993

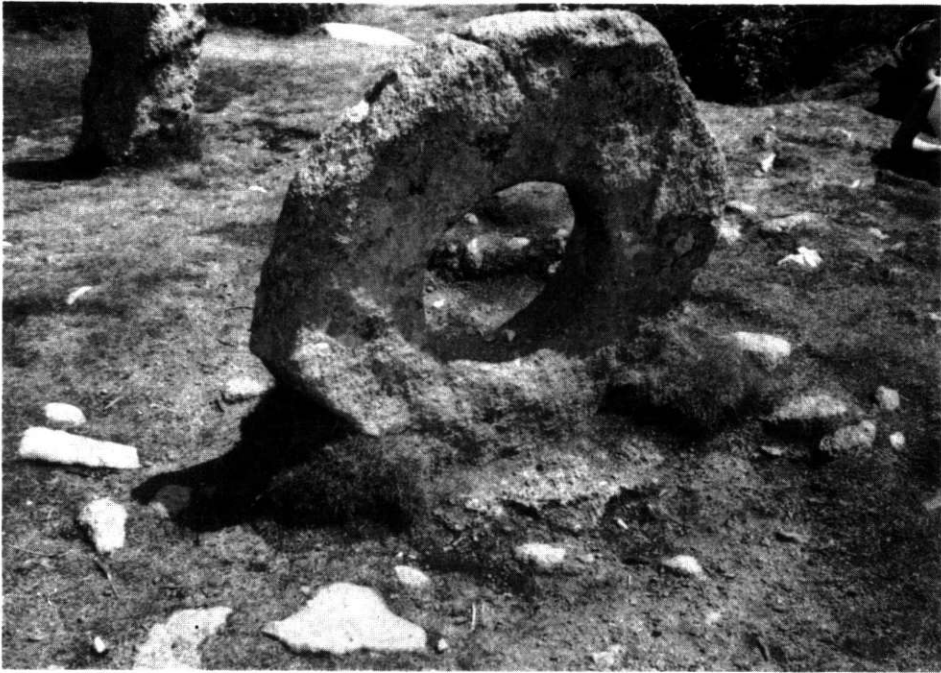
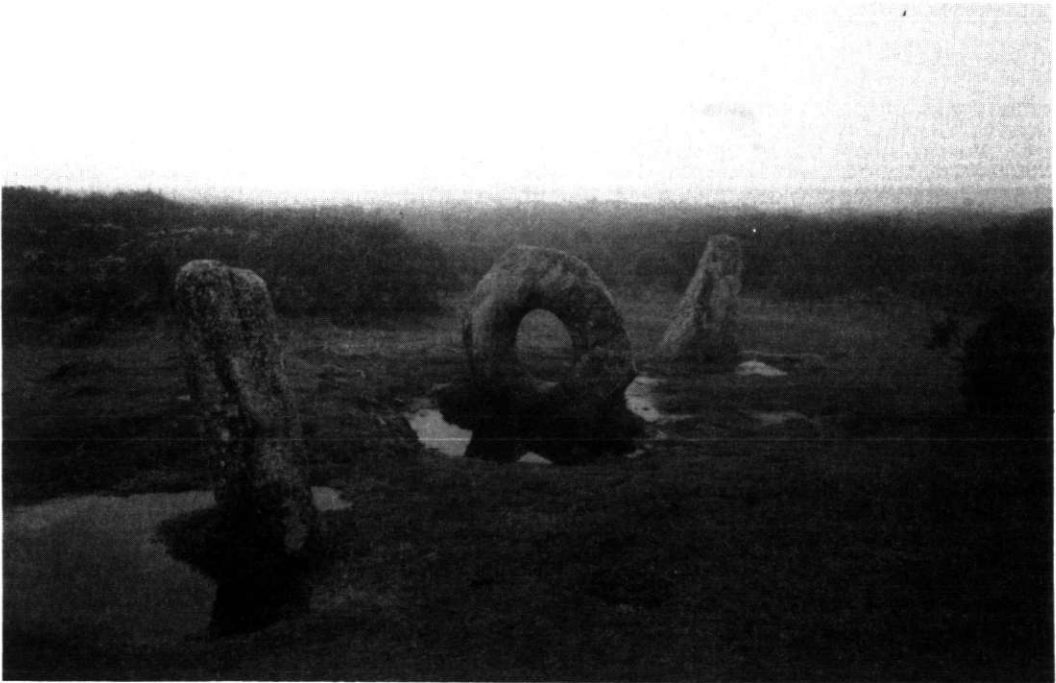
*Fig 1 The Men an Tol before management work. a) During the hot dry summer of 1989.
b) On a wet misty day in 1991. Note the eroded hollows beside the stone and the thin patchy grass
in the vicinity*

Because it attracts so many visitors, the Men an Tol is now suffering considerable damage. Until management work took place recently, visitor pressure was evident as a large eroded hollow around the stone and an increasing breakdown in the vegetation in the vicinity and on the path leading to the site. This erosion not only affected the appearance of the site but also threatened the stability of the central holed stone (Fig 1).

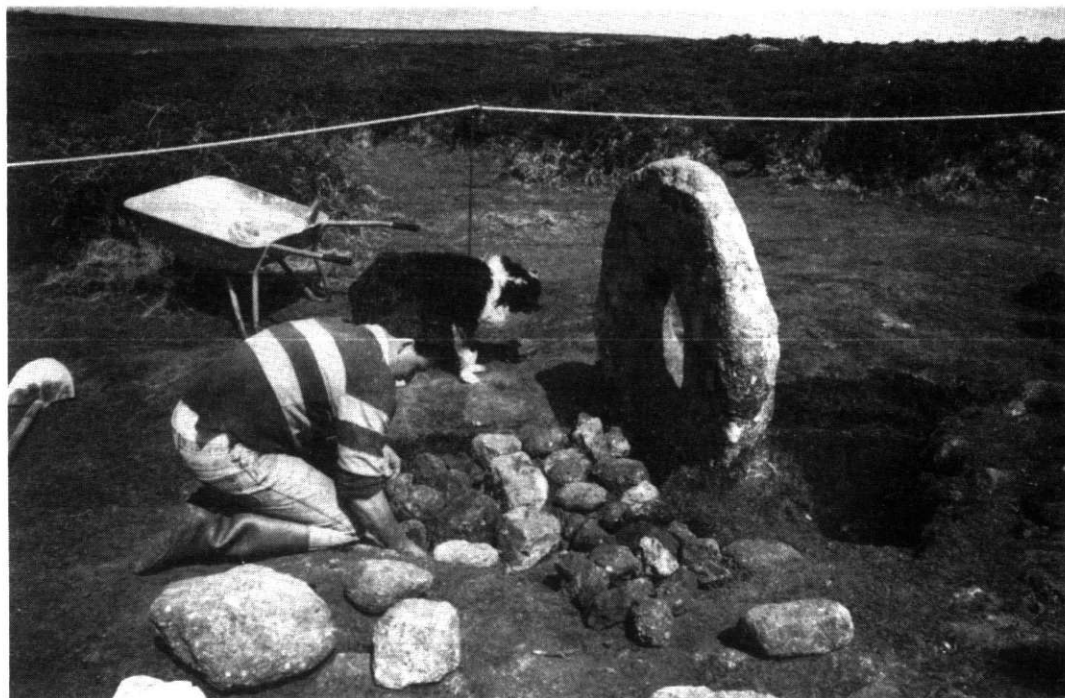
Fig 7 Stephen Bone setting pitched stones on the SW side of the Men an Tol

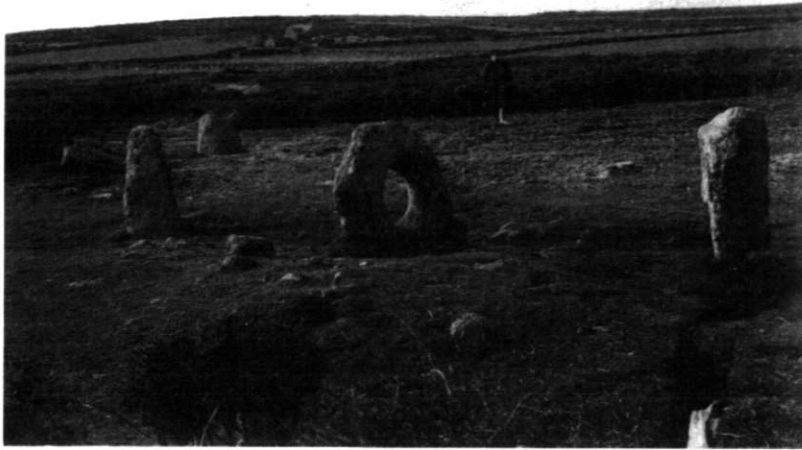
Fig 8 The Men an Tol 'stone circle' in its new setting

area of the holed stone, and to provide a better view of all the stones in the complex. It was also intended to see if any more stones in the hypothetical circle could be found, and by creating a wider clearing, to give a feeling of a circle.

The work around the stones was carried out in May 1992, and the clearing was cut in October of the same year. After a year's wear the surface around the Men an Tol comprises stones and mud which do not look beautiful but blend well and are doing their job in terms of providing a stout surface and support for the holed stone. The ground around the north-eastern orthostat has been very satisfactorily cured of bogginess, but the drainage trench leading from it is a very obvious sunken line which will have to be filled and re-turfed. Once this is done, there will be little to tell that anything has happened. By contrast, it is the creation of the clearing — which involved no actual disturbance of the monument — which has had the most dramatic and controversial effect, for it completely alters the atmosphere of the place. From an enclosed huddle of stones, the site has now become a wide open area in which the Men an Tol is only one small, if important, element. But if we are right that this complex is the remains of a stone circle, then this is the right effect. Whether it will help to ease pressure on the focal stone and improve the grass cover remains to be seen.

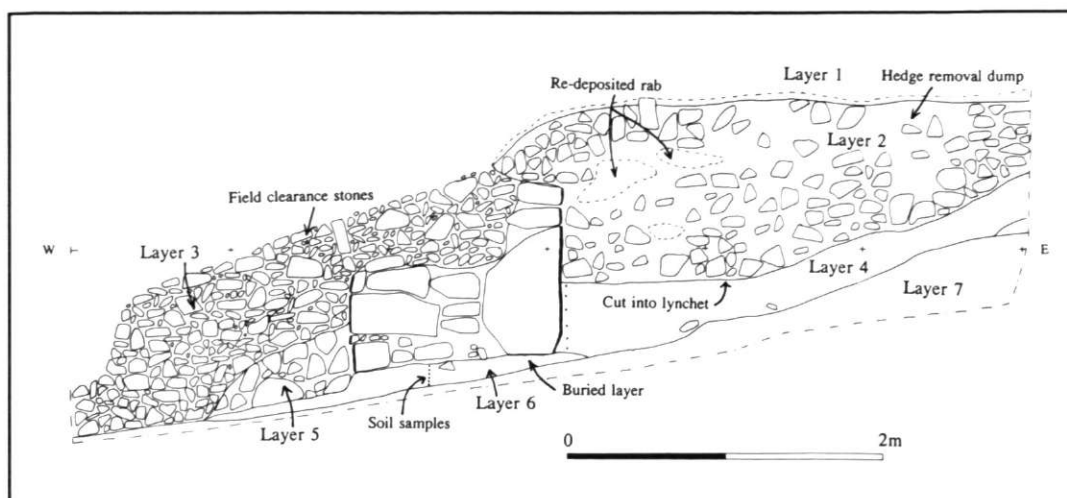
Fig 3 Foage. Section through the boundary in Trench 1. Note layer 6 buried beneath Romano-British wall

Trench 1 (Fig 3)

The stratigraphy and layers recorded will be described within a narrative account of the development of the boundary as it is visible in this trench, an account which can be broken down into 7 distinct phases:

The top of the underlying rab (layer 7 — orange granite subsoil) slopes gently down from east to west at an angle of c.15° from horizontal. This was probably the original lie of the land — the builders of the wall (phase 2) appear not to have cut a foundation trench as a buried layer of loamy material survives beneath it.

The core of the wall comprises small stones (generally less than 0.2 m max dimension) and a medium reddish brown loam (layer 5), darker than layer 4 (lynchet), and containing a considerable amount of granite sand/gravel (1-3 mm). This loam has also, of course, found its way into the heap of tumble (phase 5) on the downhill, west side.

The downhill, west face of the stone wall collapsed into a low compact heap against its foot (see section). This must have happened regularly through the wall's long life but usually such breaches or collapses were repaired to keep the boundary stock-proof. That the last collapse was not repaired is a sign either of neglect or of a change in husbandry practice in which livestock were allowed free range through several contiguous fields at one time and breaches of walls and hedges were not attended to. This appears to be a feature of 20th century dairy and stock farming in Zennor so we may assume such a date for this collapse. (It is certainly difficult to imagine James Stevens not repairing the wall!)

Overlying the cut lynchet (phases 3 and 4), the wall (phase 2) and the dump of leazing stones (phase 6) is a substantial dump of loose stones, earth and even scoops of rab. The layer (2) is up to 1.2 m thick and is the main element of the apparent lynchet.

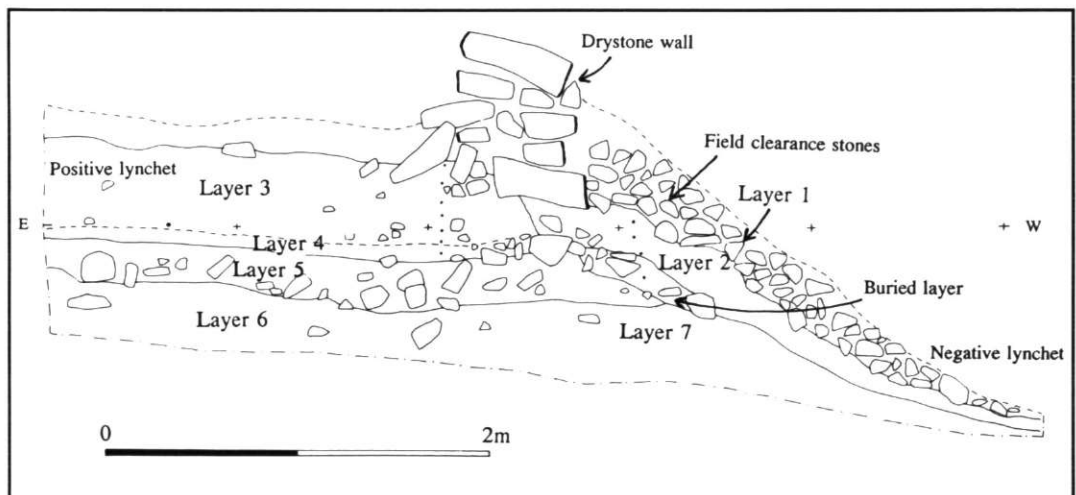
Fig 4 Foage. Section through the boundary in Trench 2.

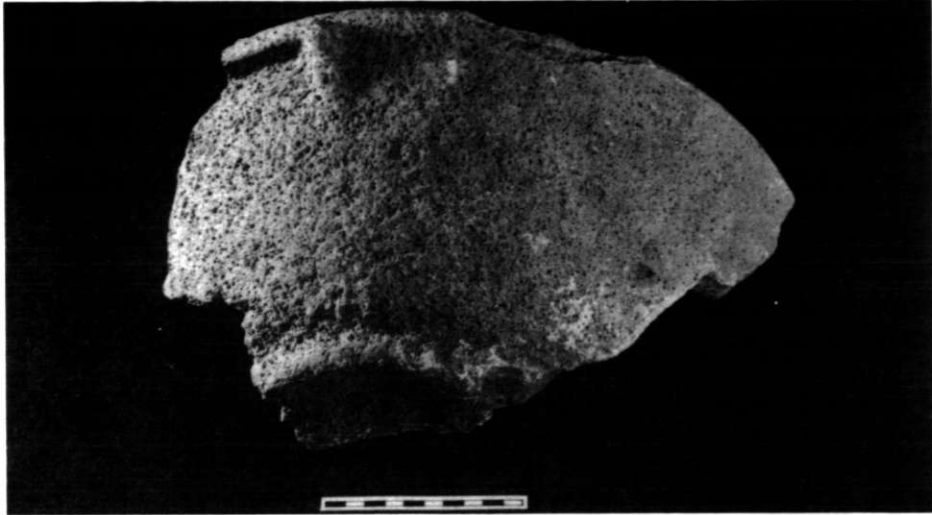
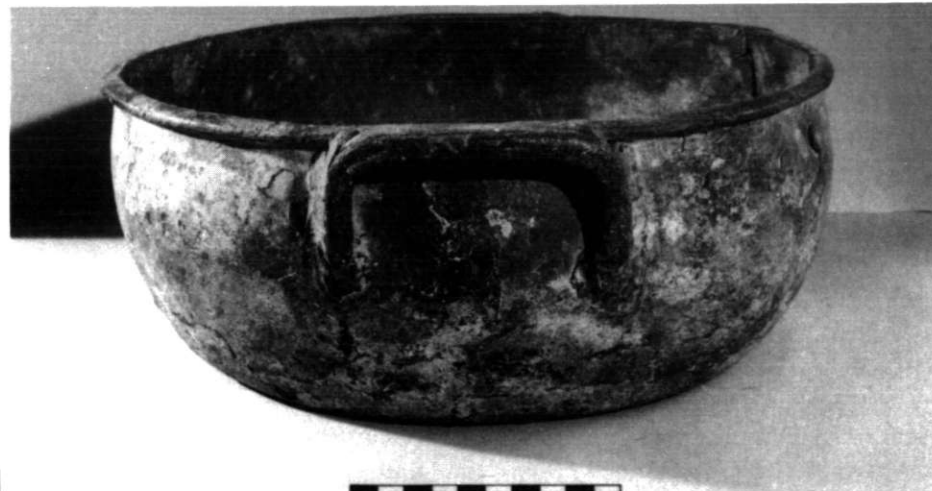
*Fig 3a and 3b Elvan Trethurgy bowl, Trethurgy; 3c Treloy tin bowl. Scale in cms.
Photos: P Brierley*

Trethurgy bowls are a mortar variant first recognised during the excavation of Trethurgy round in 1973 (Miles & Miles 1973). The six fragmentary elvan examples had maximum diameters of between 45 and 55 mm, simple rounded, chamfered, or slightly bulbous rims, and wall thicknesses thin for the size of vessel when compared to regular Cornish mortars. Four of the six had distinctive low relief handles (Fig 2), the design of which suggested skeuomorphs from metal prototypes; one example was sufficiently complete to demonstrate the presence of two symmetrically opposed handles. There is no evidence for spouts. It is debatable whether the handles project sufficiently to have been functional or were mainly decorative. They are well-finished, with all interiors used as mortars. Their contexts date to the fourth, fifth or sixth centuries. A greisen fragment from Grambla enclosure, Wendron, is about 0.50 m in diameter and has the stub end of a handle and a simple rounded rim; this site ranges in date from the second century until the sixth (Saunders 1972). Two fragments of greisen from Porthmeor have simple rims and large diameters and have therefore been included in this category. Mortars or bowls with diameters between c. 0.30 and 0.45 are not found, with the exception of that from Kerris Vean, Paul, where the surviving rim adjacent to the spout suggests a diameter of c. 0.40 m; the size difference may have some real significance. Outside Cornwall a greisen bowl was found close to Richborough in the nineteenth century (Roach Smith 1850, 104); 0.53 m in diameter, it has two opposed handles similar to the Trethurgy examples but again no spout.

The group described comprise all the true Trethurgy bowls so far recognised. With their distinctive handles, they appear to have been copied from metal prototypes, with two possible origins. The handles suggest those on bronze bowls, projecting distinctively upwards and outwards. Such bowls occur widely in the Roman Empire; a good series from the Rhineland is illustrated by Mutz (1972, 90-104). Large bronze vessels tend not to survive from Britain; in Egger's survey (1966) only one, in the British Museum with no proper location, has a remotely comparable handle (No 99). The other origin for the Trethurgy bowls is more local, the unique Treloy tin bowl found in 1830 in a tin working in St Columb Minor (Fig 3) (Henwood 1874, 221; Penhallurick 1986, 200-3). The bowl is 0.36 m in diameter, its rim has been strengthened by rolling outwards with two symmetrically disposed rectilinear handles, soldered on to the rim top and projecting sufficiently to have been functional. The illustrations show the similarity between the Treloy and Trethurgy bowls. It is as yet not clear whether the Treloy bowl is the only survivor of a group which developed functionally, the form and position of the handles being appropriate for the

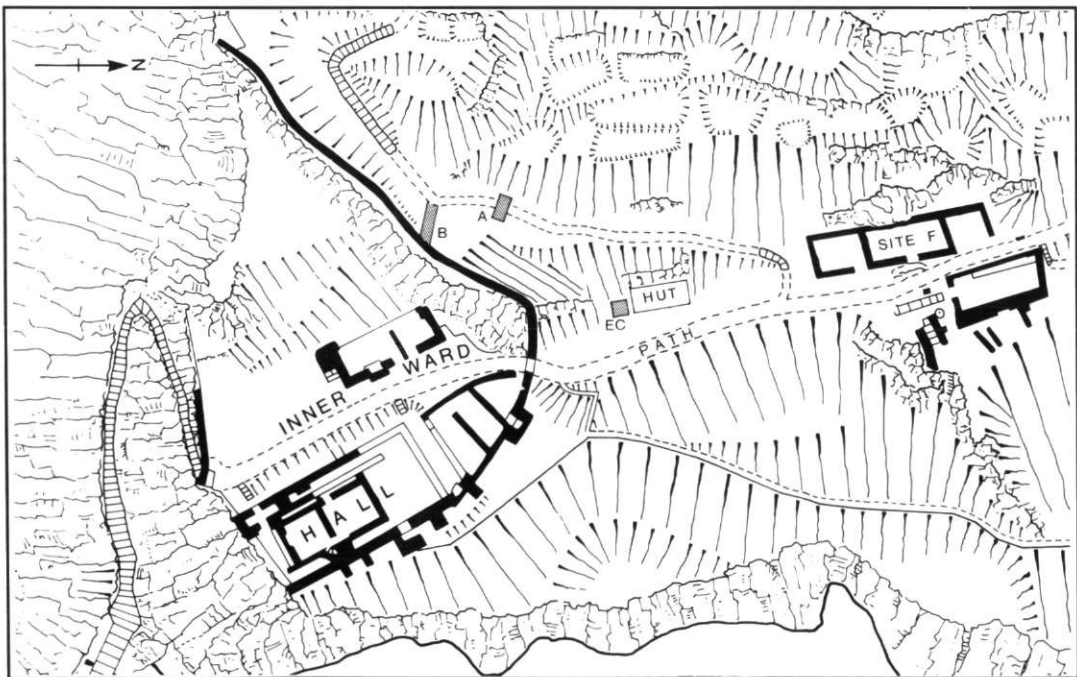
Fig 2 Location of pathway, steps and 1989 trenches, in relation to Site F. Drawn by L McEwan

To achieve the stabilisation of the surface of this particularly vulnerable route, a hard wearing surface, together with some remedial works including re-seeding, and the re-instatement of original ground profiles in the most used areas, was proposed by English Heritage. At two points above the Inner Ward where visitors most frequently pause to take photographs of the Mainland, vegetation denudation was permanent by 1989. Here, hard-surfaced levelled viewing platforms were proposed. Landscape architects Lisney and Partners suggested a schema of works in which the majority of the path reconstruction could be achieved through the building up of eroded path surfaces. However, the provision of steps up the steeper parts of the slope would require shallow excavation and surface levelling. It was in response to this schema that the Cornwall Archaeological Unit was commissioned by English Heritage to undertake appropriate evaluation excavation on the line of the path and at the viewing areas, and to assess the potential archaeological damage which would be incurred (see Fig 3). This work was undertaken by Adam Sharpe in 1989 and the results are outlined below.

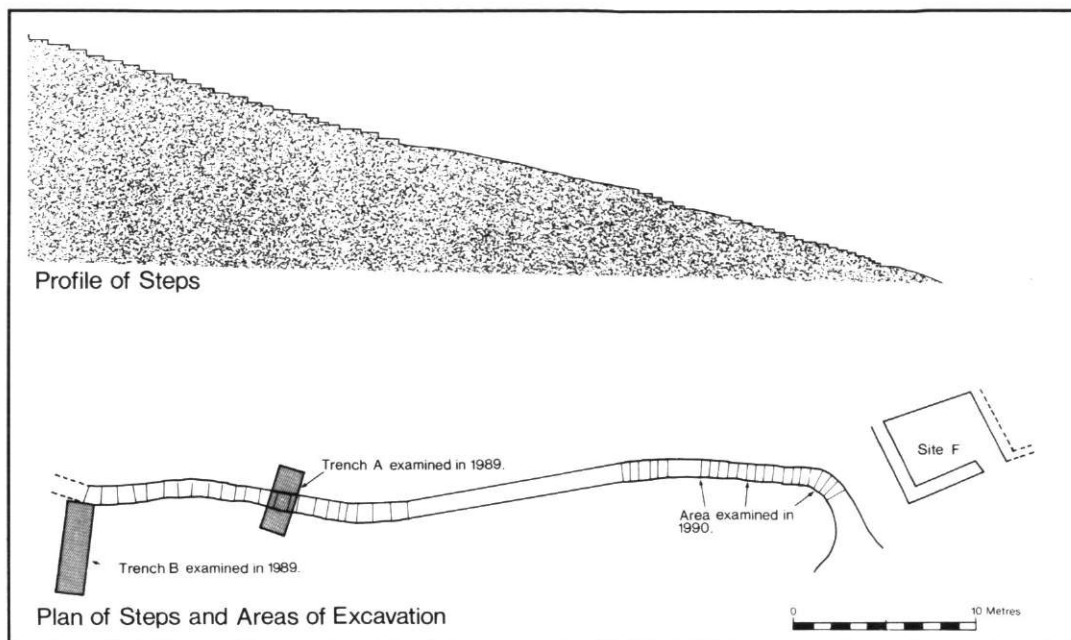
Fig 3 Plan of steps and areas of excavation. Drawn by L McEwan and R Harry

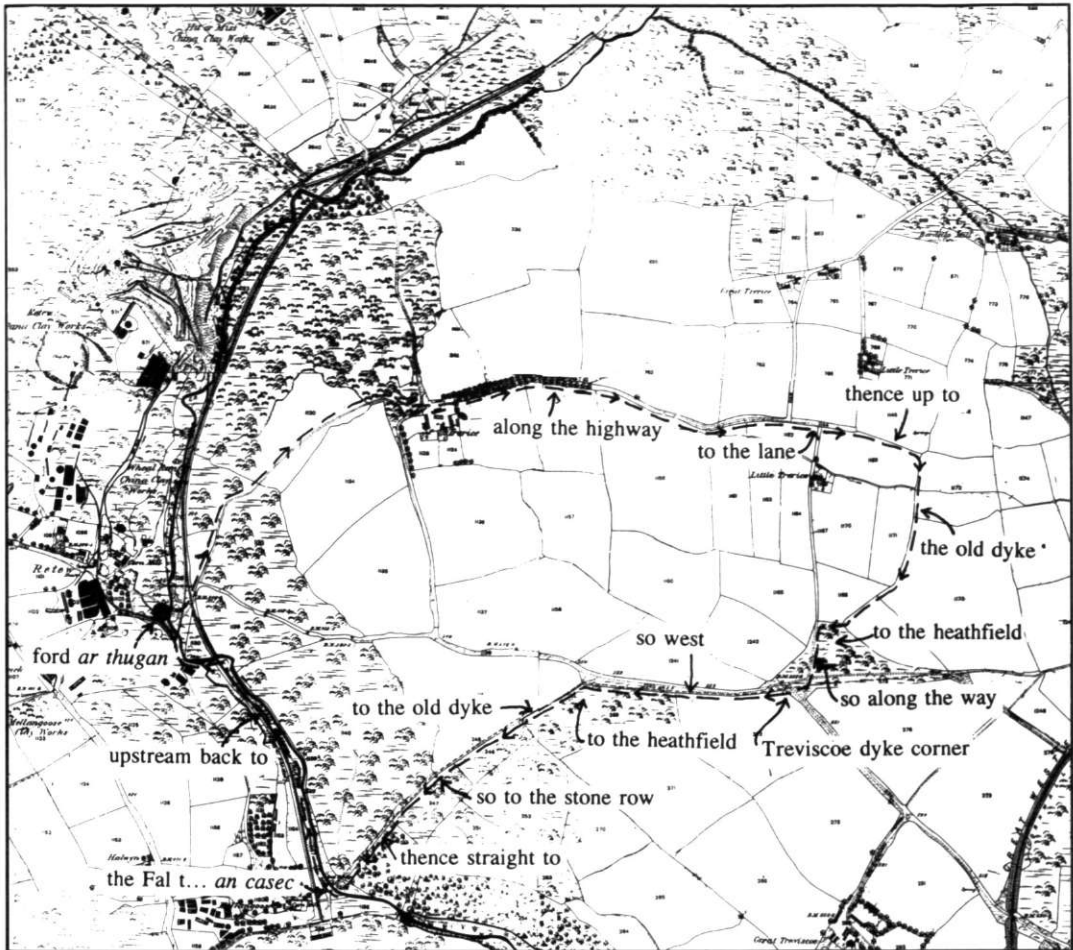
Fig 2 The 1049 Trerice boundary clause plotted onto the 1881 OS map. The eastern 'old dyke' would have continued north to 'Bordella Mill' from which the boundary of Great Trerice ran north-westwards down the stream to the Fal. This map shows clearly how the 1049 property is approximately half the area of the original Trerice

The boundary clause makes it clear that Trevice had been split by 1049 into two roughly equal parts, divided largely by the line of the 'highway'. The northern part was apparently farmed from Great Trevice (now called Rockwenna, at SW 937 575) - possibly the original Trevice - and the southern half, the land covered by the charter, presumably from the present Trevice Farm (SW 931 572). Later medieval 'disintegrations' of primary settlements and the establishment of new ones, together with consequent reorganisations of field systems, have been recorded in the 13th and 14th

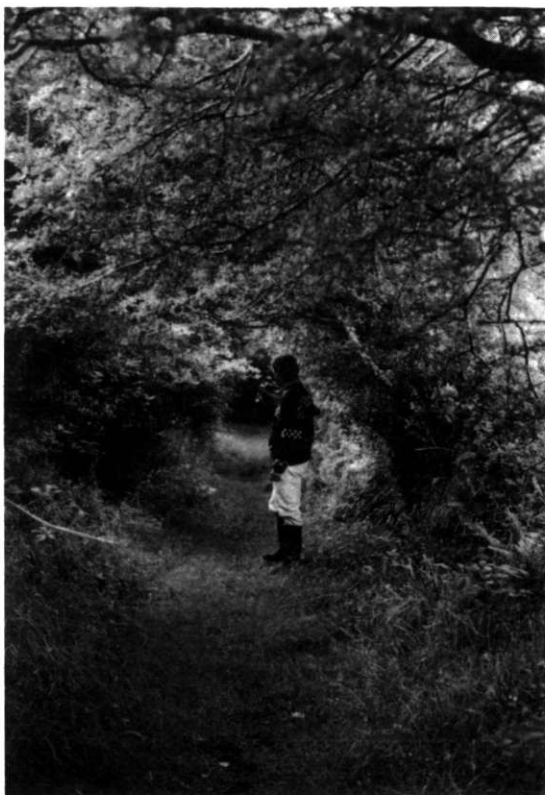
Fig 3 View down the early medieval 'way', from the 'heathfield' towards modern Little Trerice cottage. Photo: Trish Roberts.

This phrase takes our boundary up the 100m or so to Treviscoe corner (SW 9374 5678). The principal perimeter hedge of Treviscoe, the next early medieval settlement to the south (SW 938 564), followed now by the road which runs through Treviscoe village, curves at this point. The 'way' is a continuation through the heathfield of the delightful narrow hedged hollow-way, still a public footpath, which runs up past Little Trerice cottage (see Fig 3). Its age is indicated by the depth of the gully (up to 1.5m below surrounding fields) and, by following its route further south, its use as a public thoroughfare linking St Stephen-in-Brannel with the 'highway'.

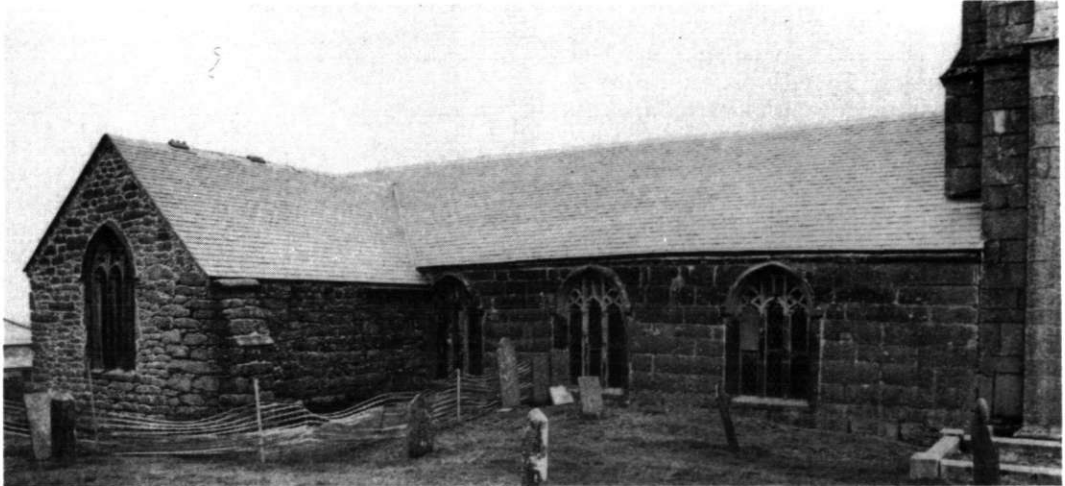
Fig 4 North side of the nave and north transept, during restoration. (Photo: Warwick Rodwell)

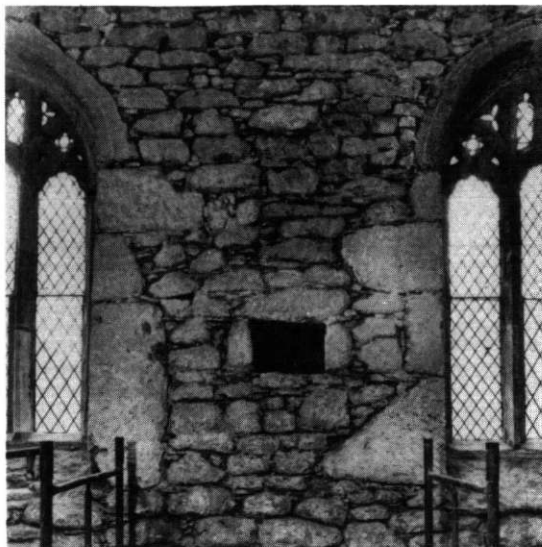
Fig 5 Socket in the north wall of the nave, exposed during plaster stripping. Note also the megalithic quoins to the rear-arches of the windows. (Photo: Warwick Rodwell)

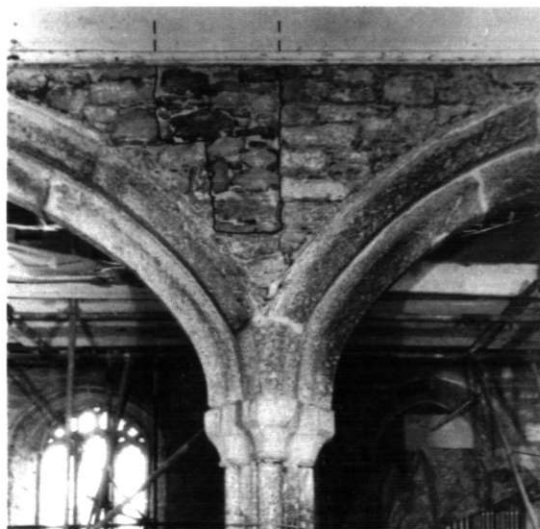
Fig 9 Detail of the north side of the nave arcade, after plaster stripping, showing the stepped infill (emphasized) of the rood-loft passage leading from the nave to the south aisle.

The well-cut granite arcade of six bays was built as a single unit, with short stub-walls at either end (Fig 2). The arches are mildly four-centred and of two chamfered orders, of which the inner is markedly hollow. The piers are of the standard Cornish Perpendicular type, the shafts being cruciform in plan, with four rolls and four hollows separated by small steps. The octagonal 'tablet' capitals have plain facets and neck-rolls. They are combined with the abaci, which are decorated on each facet with a four-petalled motif, carved in low relief. Identical work is seen in the arcade to the north-east chapel in Luxulyan Church.

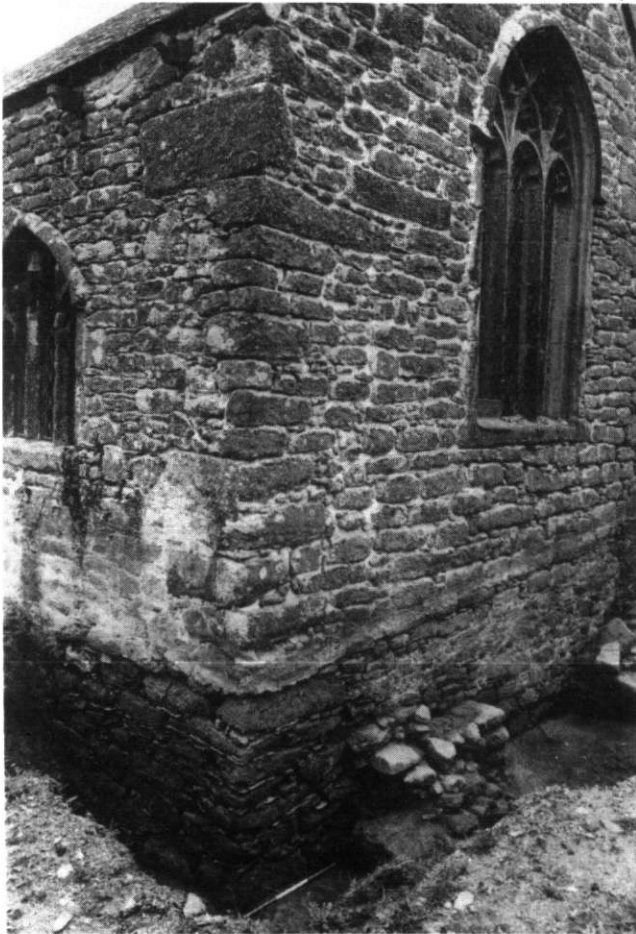
Fig 10 North-east quoin of the north transept, the earliest surviving masonry in the church. Note the preservation of the slate packing between courses, below former ground level. (Photo: Warwick Rodwell)

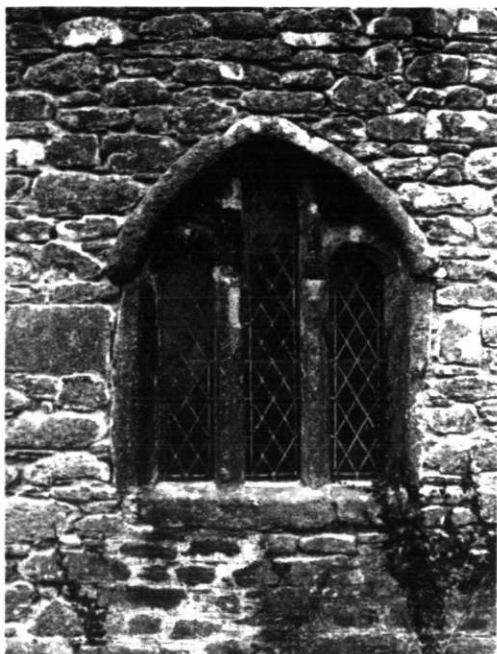
*Fig 11 Simple triple-lancet window in the east face of the north transept, the earliest extant architectural feature in the church.
(Photo: Warwick Rodwell)*

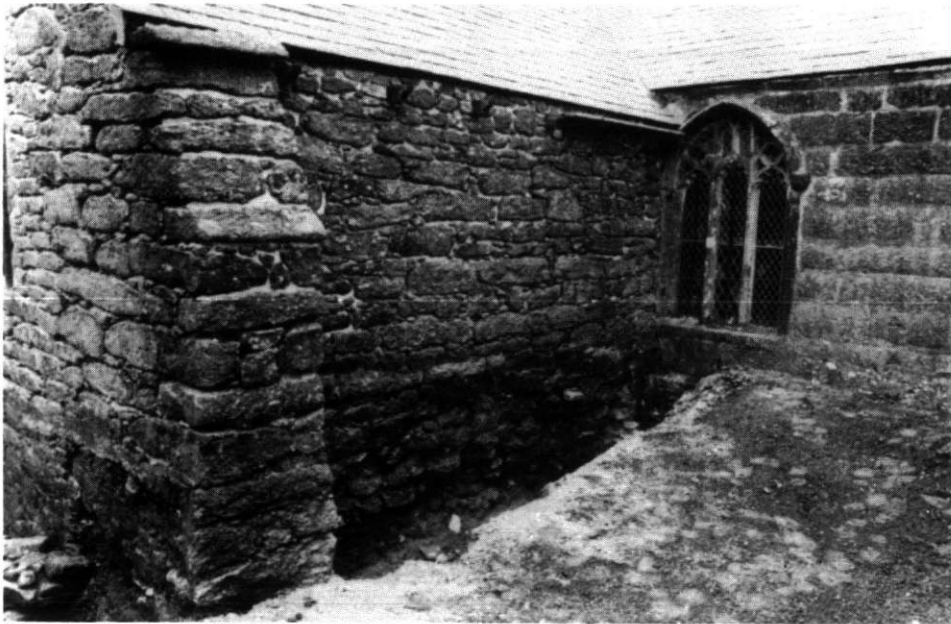
Fig 13 Buttressed west wall of the north transept, showing the loose rubble foundation exposed in a drainage trench. (Photo: Warwick Rodwell)

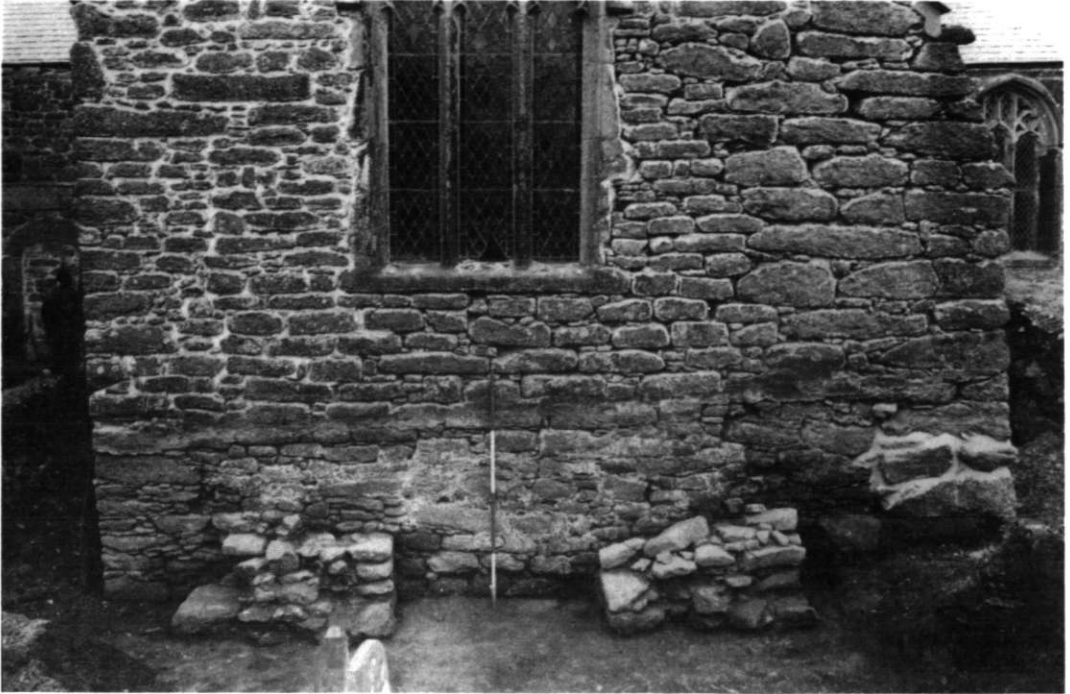
Fig 14 Lower part of the north wall of the transept, showing the foundations of the former north tower exposed during drainage works. The three main phases of construction of the wall are clearly seen: left, the original masonry and quoin; centre, infill, refacing and new window following the removal of the tower; right, rebuilt quoin and added buttress. (Photo: Warwick Rodwell)

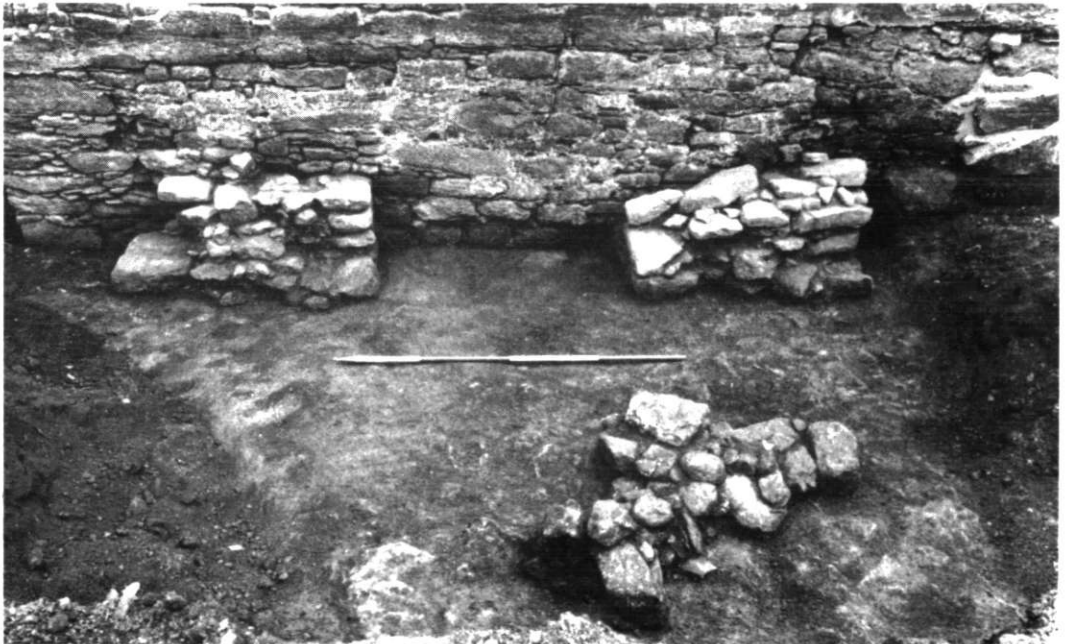
Fig 15 The three surviving foundation fragments of the former north tower, exposed during drainage and landscaping works. (Photo: Warwick Rodwell)

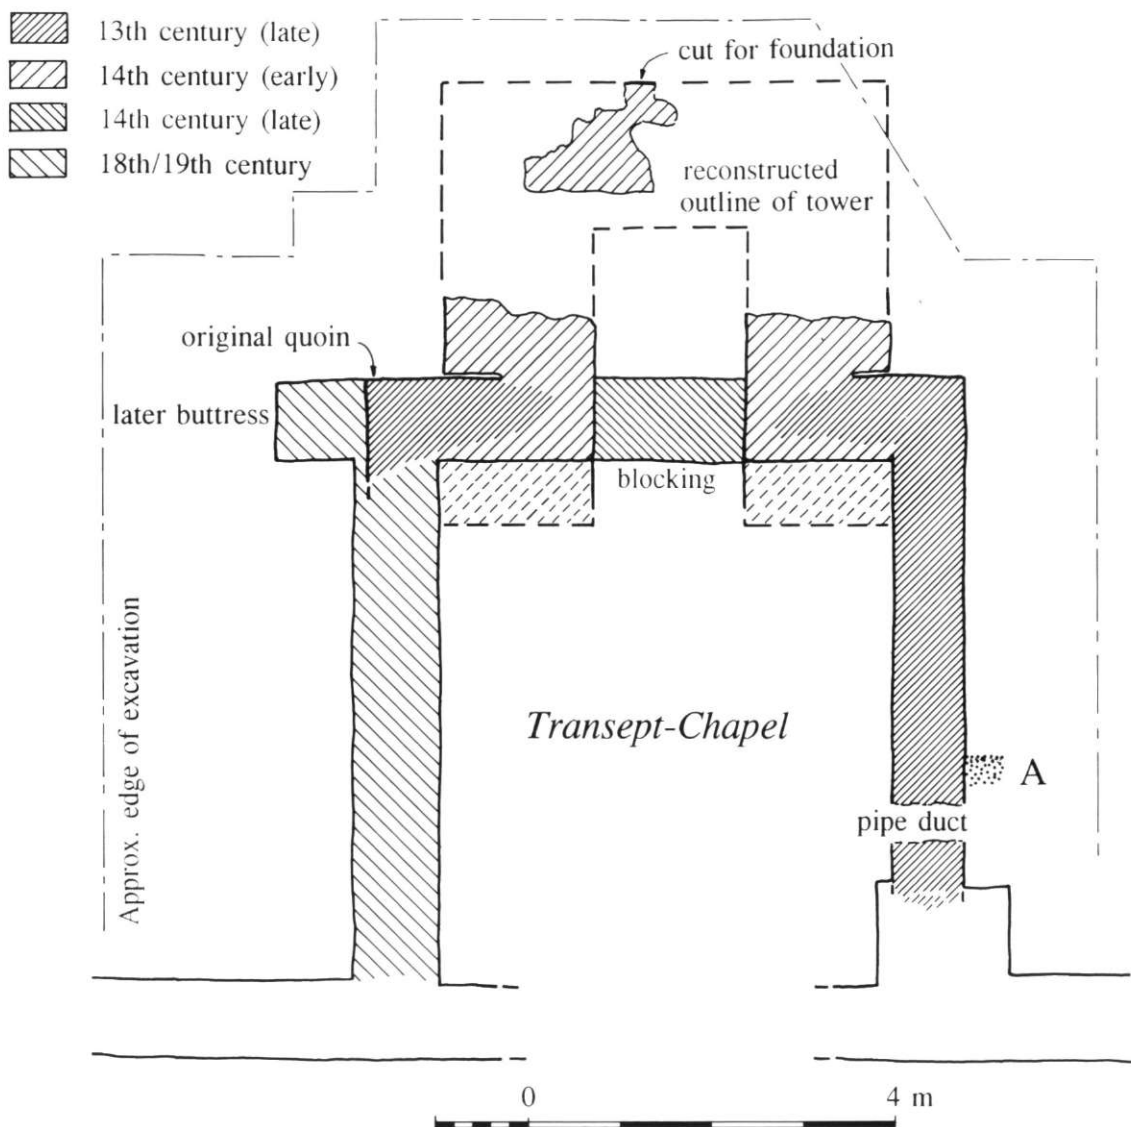
Fig 16 Foundation plan of the north transept and former north tower, showing the four periods of construction. The small patch of foundation masonry at 'A' is undated.

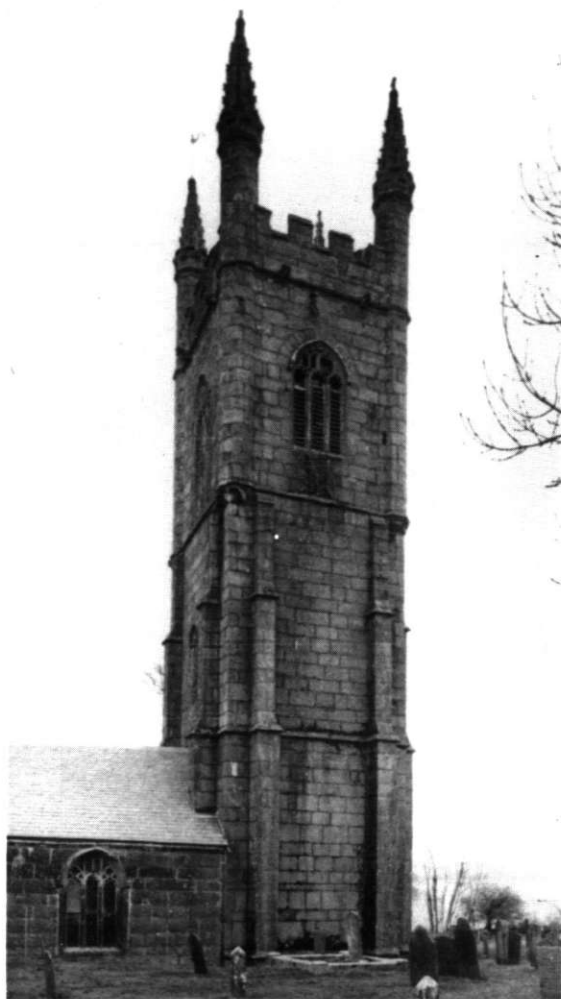
Fig 17 West tower and nave abutment, viewed from the north. (Photo: Warwick Rodwell)

The tower, which is of three structural stages, plus a parapet, is built of granite ashlar both externally and internally, with slate used to level the courses. Its walls have never been plastered. The stage divisions are marked by simple chamfered string-courses. Pairs of buttresses clasp each angle and rise to the top of the second stage, where they are crowned by sculptured corbels carrying the octagonal corner turrets. These rise well above the parapet, their tops are embattled, and each is finished with a crocketed spirelet. Perpendicular in style, and 29.5 m (97 ft) tall, the tower is plainly of one build throughout (Fig 17). In its lowest two stages the tower is closely similar to its neighbour at Luxulyan.

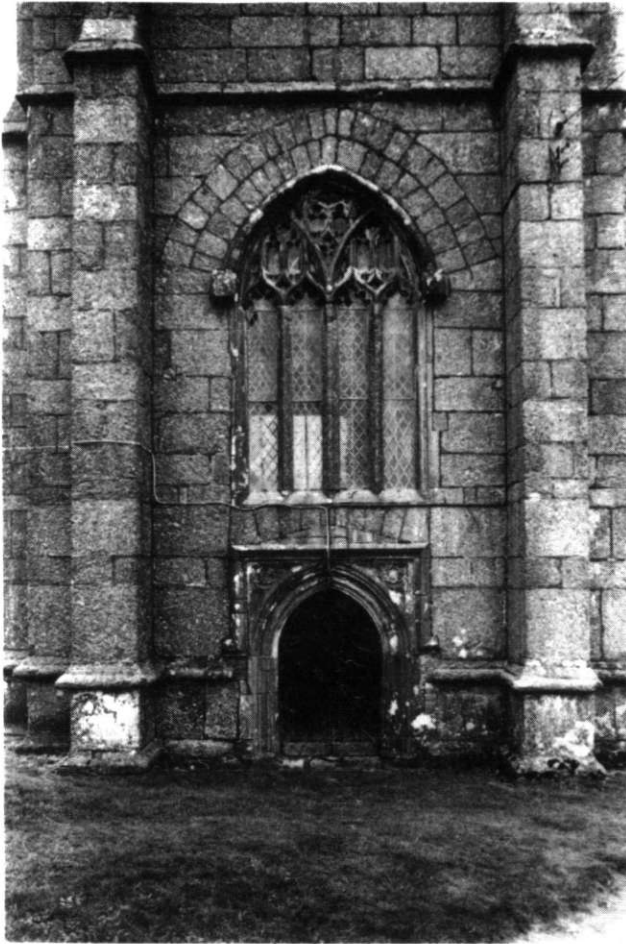
Fig 18 Ground stage of the west tower, showing the modest doorway and large window with uncarved label-stops. (Photo: Warwick Rodwell)

The west face is dominated by a substantial doorway, and an even more substantial window above (Fig 18). The mouldings of both are finely cut from grey igneous stone. There are two orders of hollows and rolls defining the two-centred door arch, over which is a heavy, square hood with a deep drop and

of the sill, but this is not matched on the north, where the stooling remains square and uncut (Fig 25A). It is unfinished. The hood moulding terminates in two large, cubical blocks of unmoulded stone: these were intended for the carving of elaborate label stops, probably in the form of addressed human heads. The sculptures were never begun, and Glynne (1862) referred to the stones as 'block corbels'.

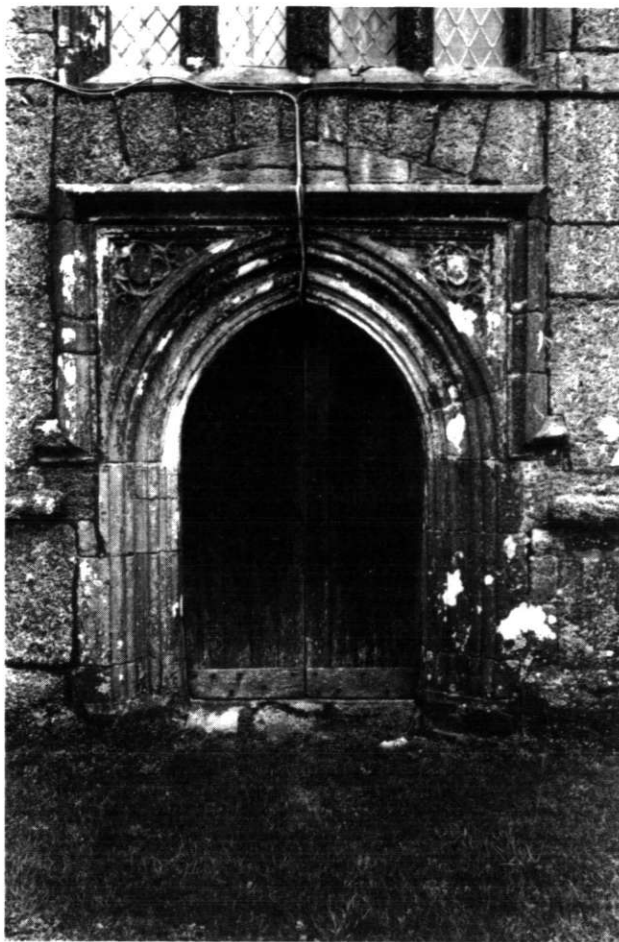
Fig 19 Detail of the west doorway with its heavy label-moulding, squat proportions, and uneasy relationship to the tower plinth. (Photo: Warwick Rodwell)

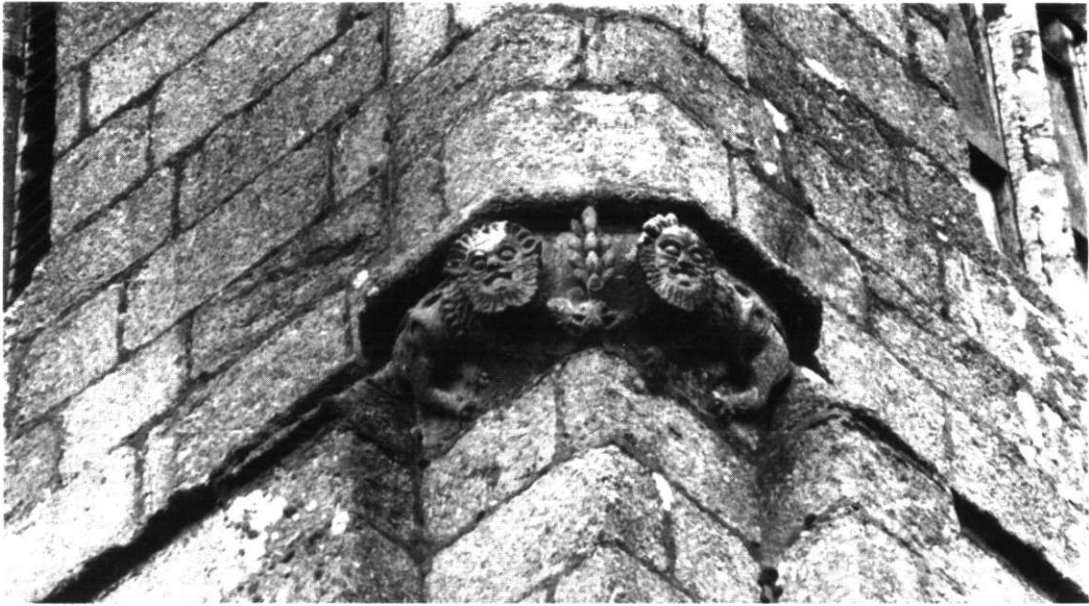
*Fig 20 Sculptured corbel supporting the south-west corner turret of the tower.
(Photo: Warwick Rodwell)*

The octagonal corner turrets of the third stage rise from massive, flat corbels. The south-west corbel bears the finest sculpture, an enchanting pair of lions facing one another, flanking a wheat ear (Fig 20). The south-east corbel has two complete crowned human figures, in 'flying' posture, holding a head between them. The two northern corbels depict angels, flanked by crude human masks.

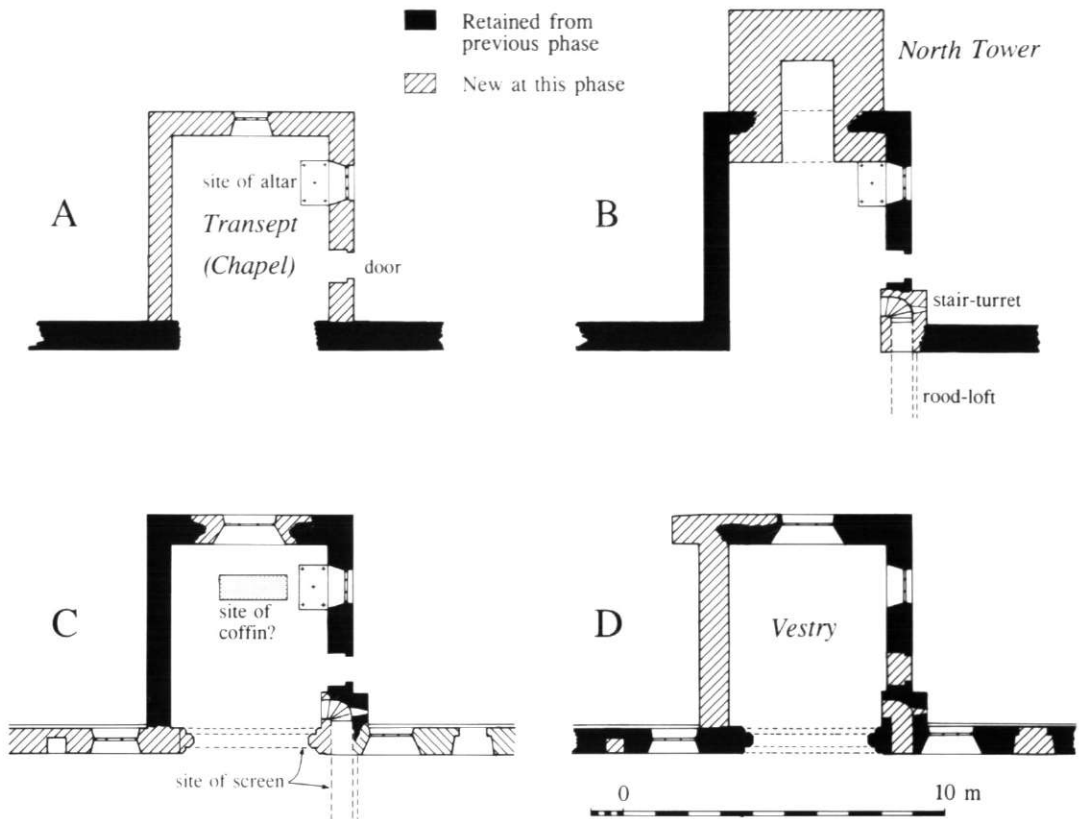
Fig 21 Plans illustrating the development of the north transept and tower. A. Later thirteenth century; B. Late thirteenth or fourteenth century; C. Late fourteenth century; D. Seventeenth to early nineteenth centuries.

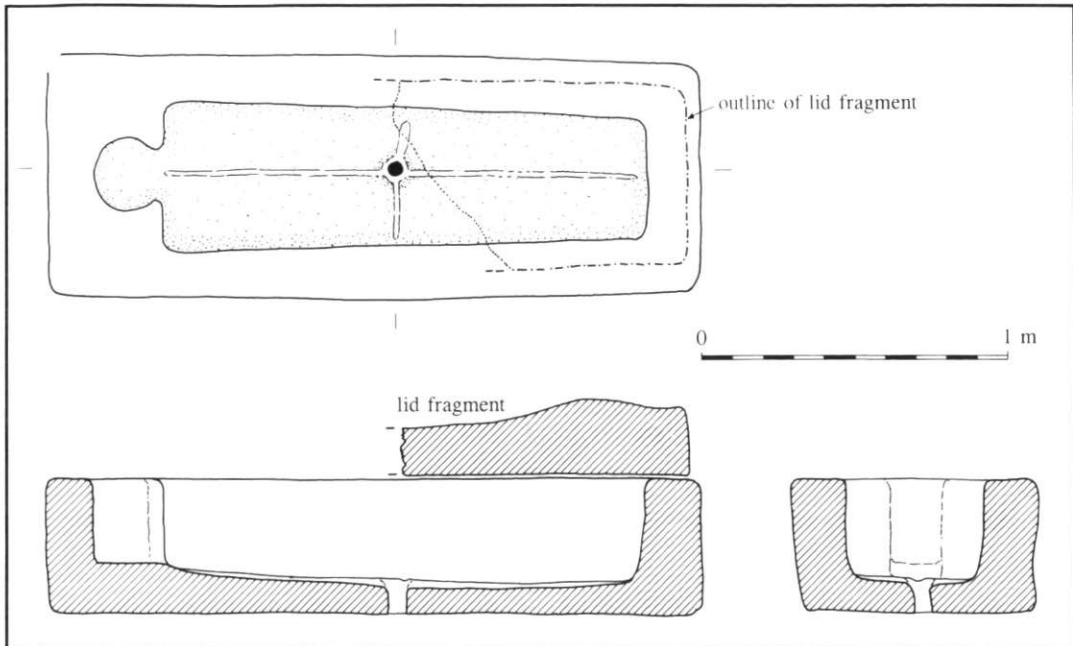
Fig 22 Sketch plan and sections of the granite coffin found in the north transept, now in the churchyard.

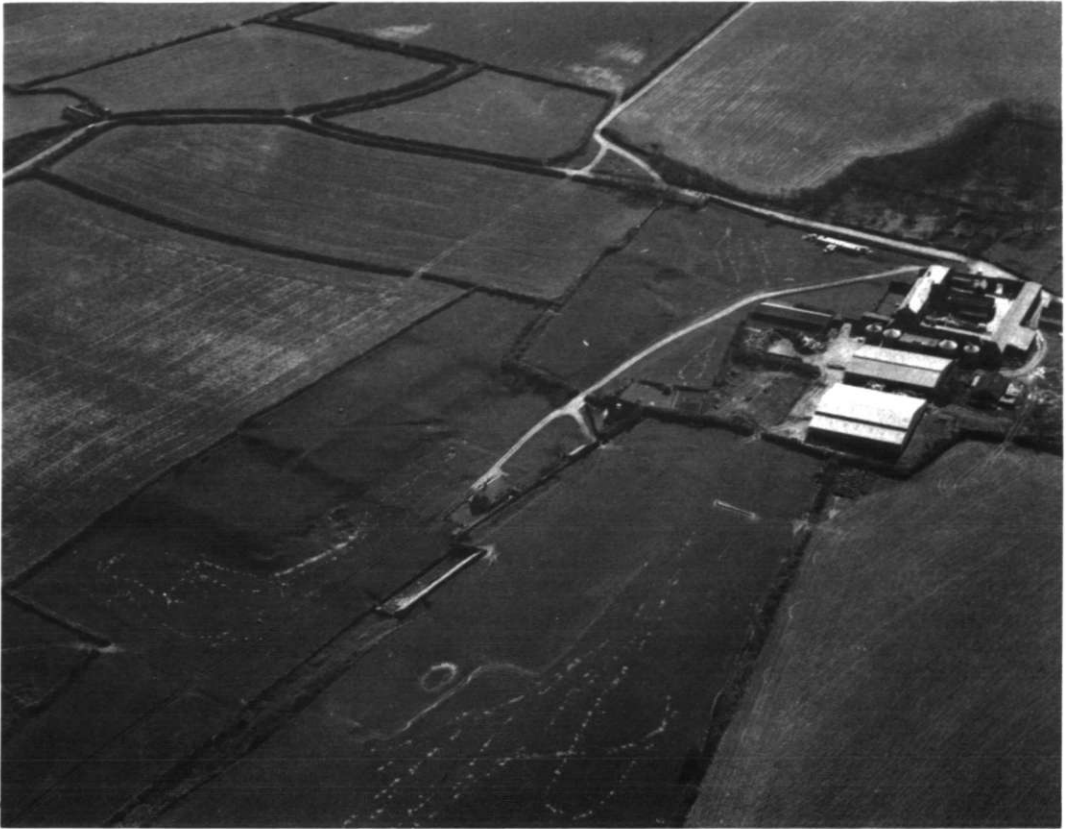
Fig 5 Stowe: aerial photograph from the north-east, April 1987, serial no CAU/ABP/F11.71; NMR no APR 2352/5/72. (S. Hartgroves, Cornwall Archaeological Unit. Copyright Reserved).

ground by earthwork terraces rising up to 3.4 m in height (Fig 5). The picture now is one of dramatic changes of level within the garden, an effect which would have been even more impressive when the original walls bounding the compartments existed, as shown on one of the 1716 drawings (Harris, 1964, no 101). This, as well as the plan of 1694, indicates that each compartment was an enclosed garden in its own right, being connected to the others by doorways and flights of steps. In at least two of the southern line of compartments, massive cross-scarps indicate that there were considerable internal differences of level. The importance of the terraces and other level changes, though partly a constructional element of the gardens, was also vital in terms of the aesthetics of the original design and the way in which they were intended to be viewed. A further advantage, particularly in the exposed maritime position in which the gardens lay, would have been to achieve better protection for, and to allow a greater diversity of, plants.
