CORNISH ARCHAEOLOGY

No 32 1993

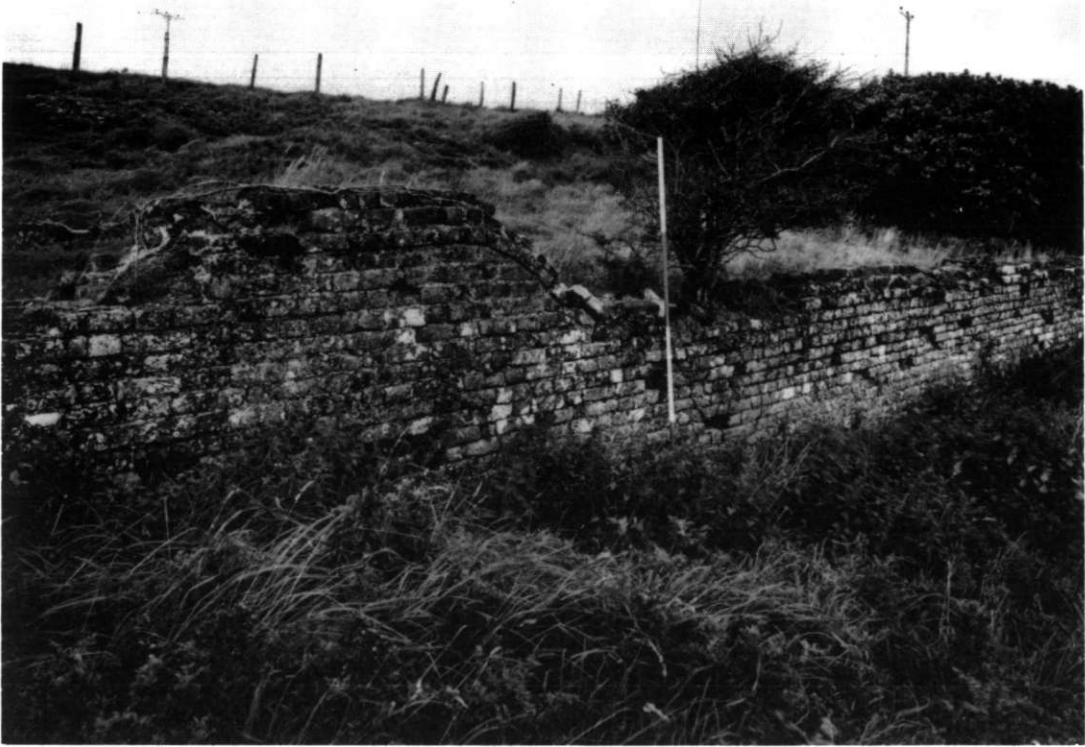
Fig 6 Stowe: seventeenth-century walling to north of the site of the 1670s house. (RCHME Crown Copyright)

The only part of the original walling of these gardens that survives is a length along the northern side of the northern compartments (Fig 6). This is, therefore, among the earliest examples of surviving brickwork in Cornwall, the best known from the 17th century being at Ince Castle, Saltash (Clifton-Taylor, 1983, 30).

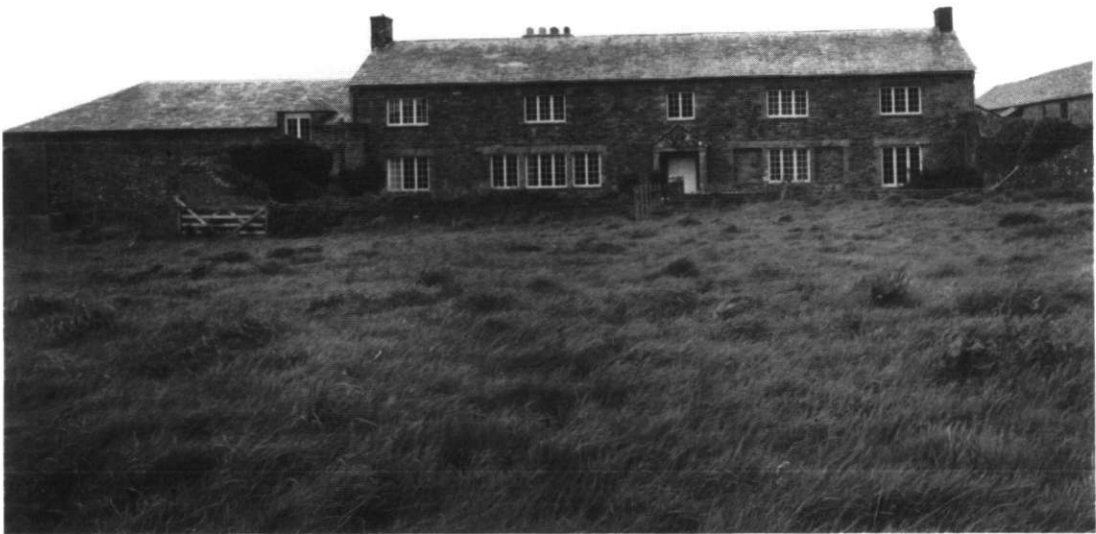
Fig 8 Stowe Barton farmhouse from the south. (RCHME Crown Copyright)

The northern and north-eastern part of the existing rectangular area is occupied by Stowe Barton farmhouse and its associated buildings (Fig 8). Most of the latter are recent, or at least of 19th-century date. The T-plan farmhouse itself is older despite the present main south elevation which is largely 19th-century in date. Although the farmhouse is difficult to date because of its stone rubble construction and the lack of original architectural features, its position and T-shaped plan suggest that it is, in fact, the southern half of the H-shaped stable block shown on the 1694 plan. The date of the stable block has been assumed to be late 17th-century and contemporary with the construction of the mansion, mainly because it was depicted in 1694. It may be, however, that its origins are in the earlier part of the 17th century and that, in fact, it is the stable recorded as being built by Sir Bevil Grenville in 1621, no doubt enlarged and embellished at the time of the construction of the 1670s house.

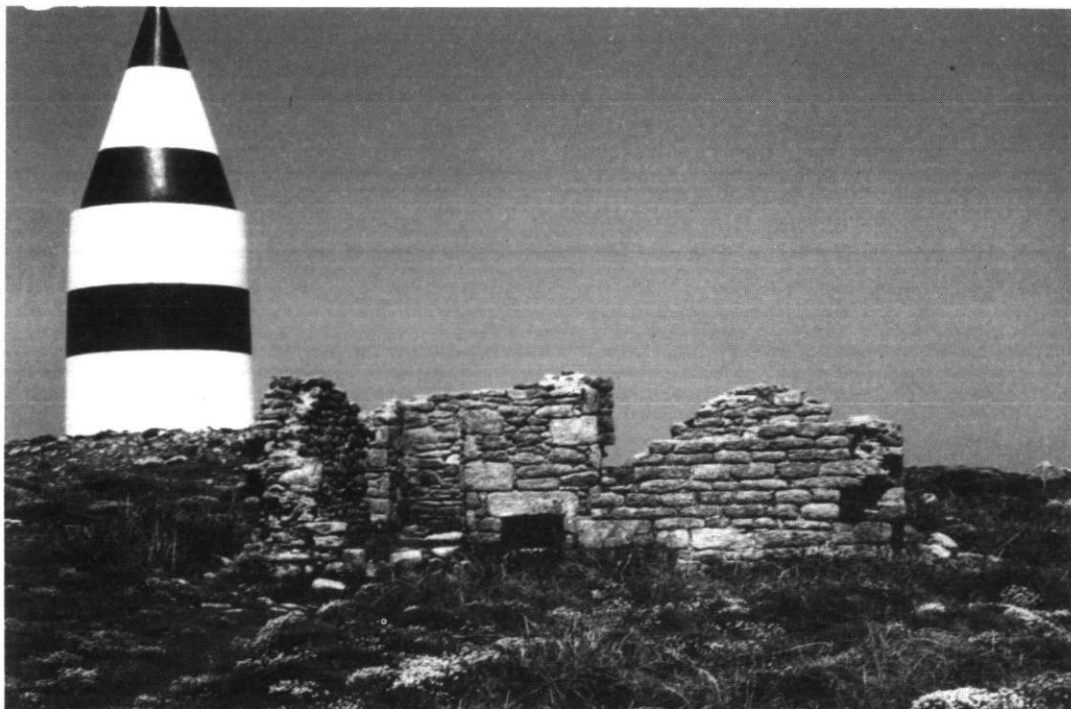
Fig 2 Chapel Down, St Martin's. The Seamark dominates the ruins of the Admiralty signal post built in 1804. Photo: author, 1992.

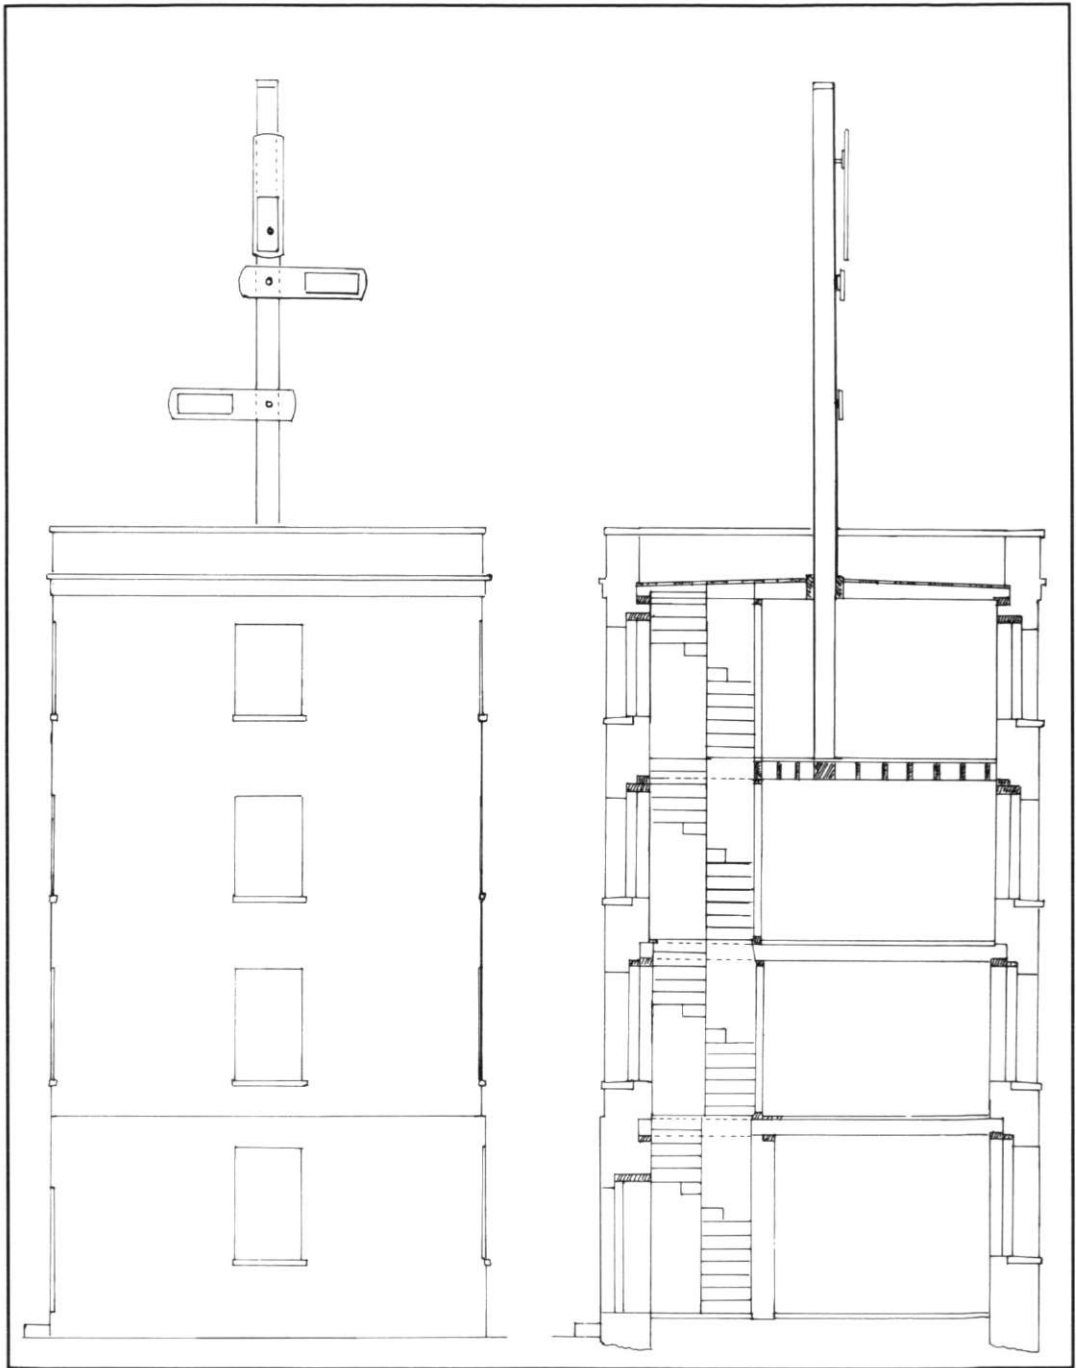
Fig 3 Elevation and section of Newford Down Semaphore Tower. Each floor has a closet under the stairway. From drawing captioned '... a signal tower proposed to be erected at Newford Down...' PRO ADM 140/655.

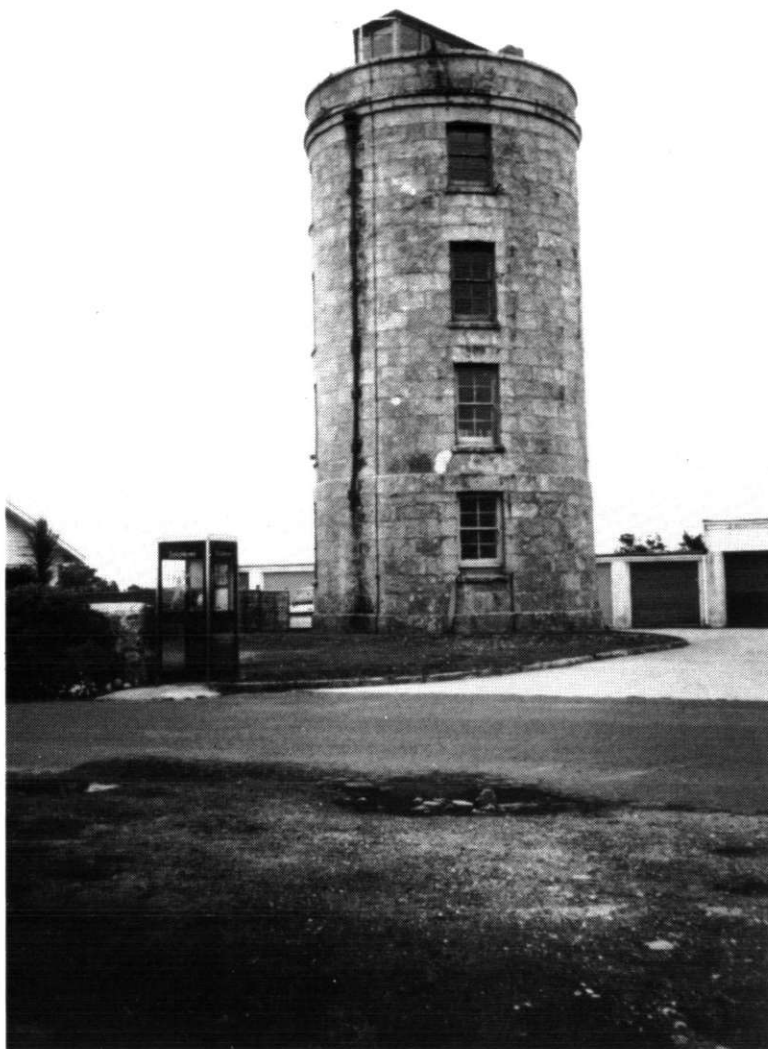
Fig 4 Newford Down, St Mary's. The Admiralty semaphore station, now known as Telegraph Tower. Photo: author, 1992.

Under the terms of the lease with the Duke of Leeds the signal tower reverted to the custody of his steward until it was wanted again by the Admiralty. However, it was to be taken over later by the Coastguard. In 1903 a wireless mast and receiving office were built nearby and five years later a telegraph house was erected on the roof of the tower by the contractor, Arthur Carkeek²¹. During this latter part of its history it became known as Telegraph Tower and it still stands today near the junction of Pungies Lane and Telegraph Road (Fig 4).

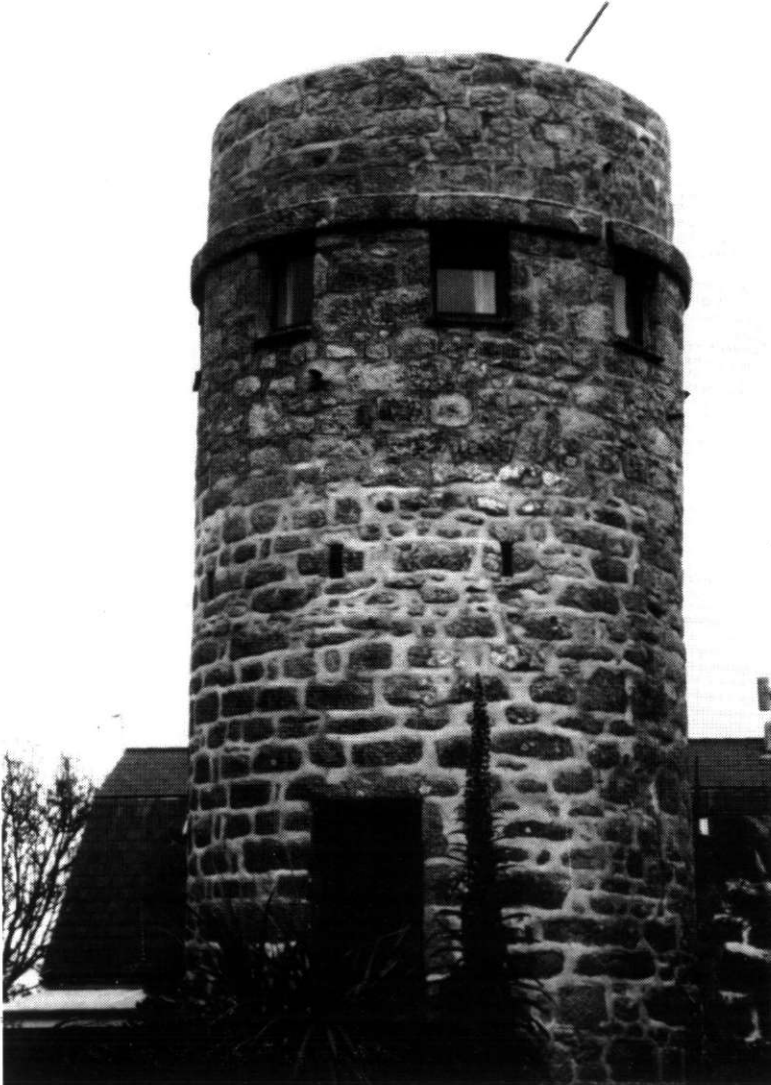
Fig 5 Garrison Tower, St Mary's, formerly a 16th century windmill and later rebuilt for use as a Lloyd's signal station. Photo: author, 1992.

Today only one granite tower remains on Garrison (Fig 5), the second shown as a ruin on late 19th century maps has disappeared. The survivor stands surrounded by trees within a few metres of the entrance to the defensive barrack block excavated to house the custodian and men of the Steval and Woolpack batteries which were established in 1898³⁸. The circumstances in which this remaining *ruined obelisk* in Troutbeck's survey was changed into the present substantial tower are known in outline, but are obscure in detail. Towards the middle of the 19th century the Coastguard apparently occupied the tower when they moved from using the old windmill on Peninnis Head as a look-out³⁹. About 1869 the tower was then acquired by the Shipping Gazette, a vigorous commercial rival to Lloyd's List - both firms collected and published intelligence about ship movements for the London markets. Lloyd's of London took over the station on 7th June 1871, and bought the site on 20th September 1882. The purchase price was £500, but this is believed to reflect the business value as well as that of the signal station and accommodation for seamen⁴⁰. The repair

Garrison Tower, SV 8980 1033 (Fig 5)

In 1989 and 1990 the Cornwall Archaeological Unit surveyed the fortifications on the Garrison headland⁴⁶. Their reports included a description of the former windmill, but wrongly identified it as a Martello tower. It is in good condition and is now a residence. Attempts to establish conclusively the nature of the changes made during the latter years of its 19th century history have not so far been successful, but may be possible eventually if the Deeds can be examined.

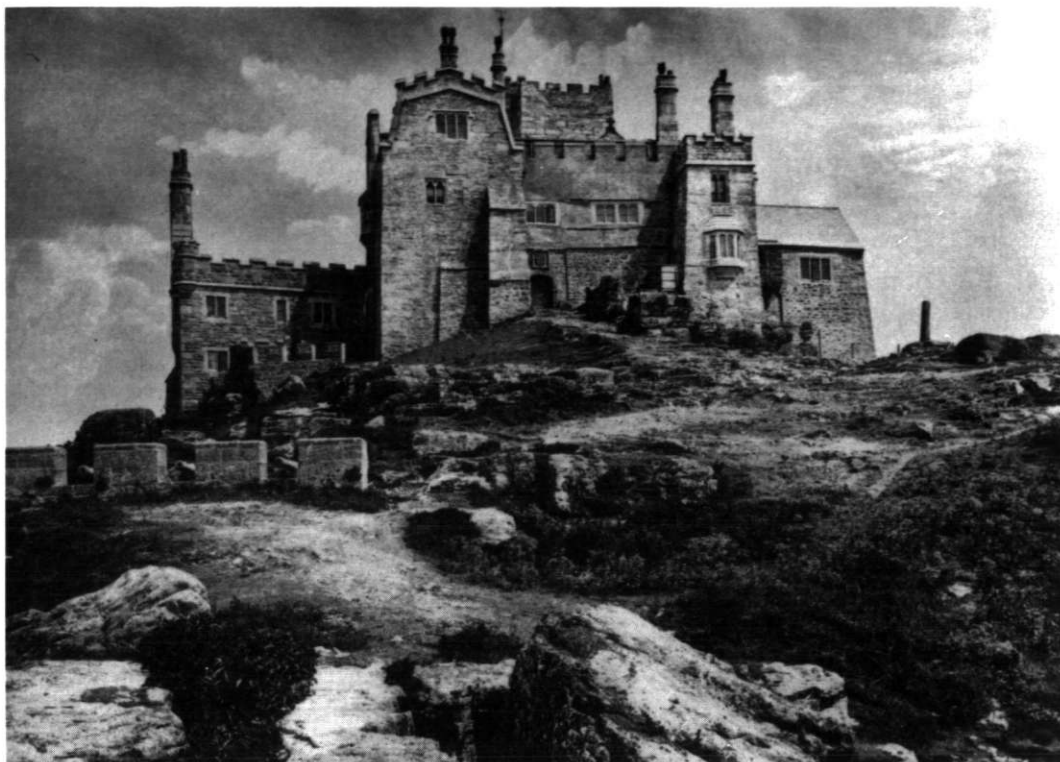
Fig 1 The early 20th century Gibson photograph of the west end of St Michael's Mount summit complex. Imagine away the 19th century extension to the north (left), the mansard gable on the large tower to the north of the door, all the chimneys, and Piers St Aubyn's pseudo-medieval windows, and the sturdy later medieval castle re-emerges. Poking up behind, itself battlemented, is the priory church's tower, with the fragment of medieval lighthouse on its south-west (right) corner. The remains of a medieval curtain wall were recorded curving from behind the 18th century battery in the foreground to the cross-shaft (right); this protected the long flight of steps running up to the castle. (Courtesy of the Royal Institution of Cornwall).
